Subject: March 11, 2025, Sanitary Sewer Discharge Report
WPDES Permit No. WI-0036820-04-0

Incident Summary Report
Overflow Incident at Hampton Avenue (03/11/25)

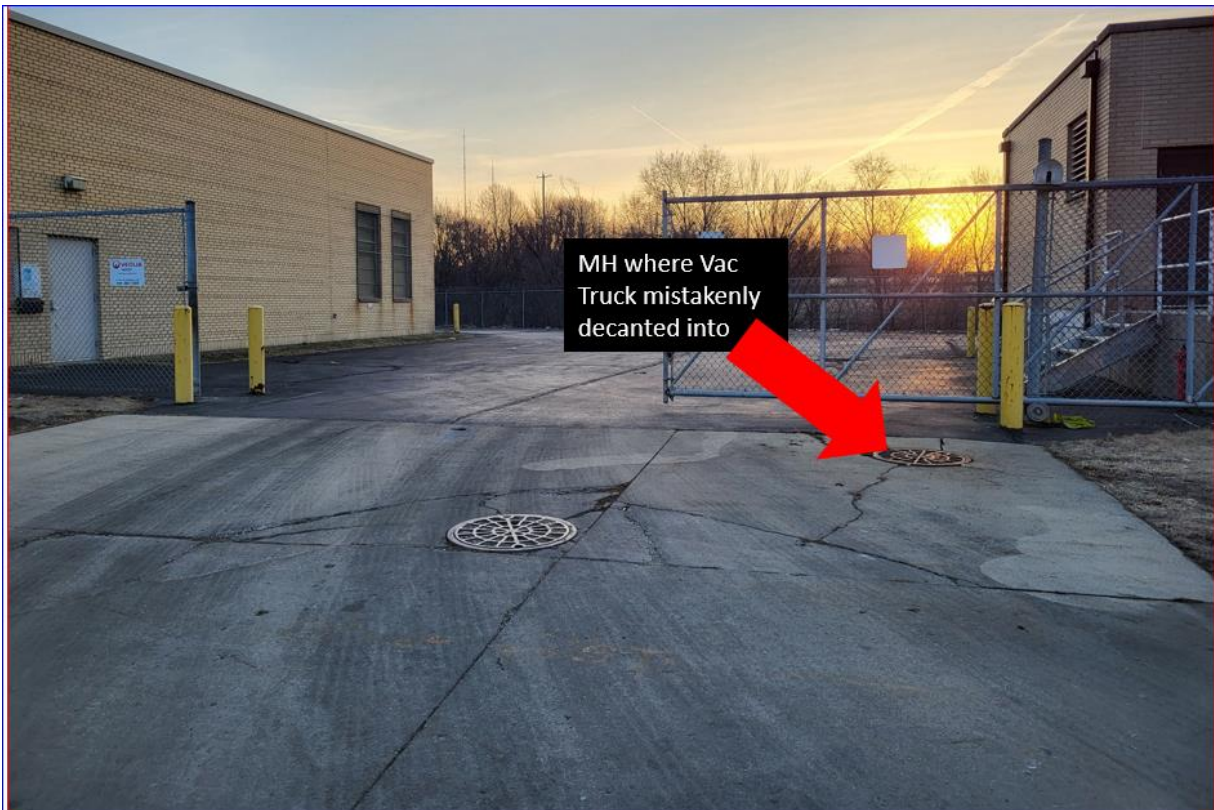
It was discovered by our staff that at approximately 2:45 pm on Tuesday 03/11/25, our vacuum truck crew had mistakenly decanted vacuum truck (vac truck) contents into a wrong manhole. Approximately 9,600 gallons of water was mistakenly decanted into a storm sewer that ultimately discharges into Lincoln Creek. The Veolia field crew was providing construction support to MMSD's *MCCR 1612 Hampton Avenue North Siphon Gate Replacement Project* by dewatering standing water from Infiltration/Inflow (I/I) in a structure using a vacuum truck.

Manhole where Vac Truck decanted into

- Starting immediately, Veolia has implemented **Mandatory Supervisor Verification and Approval** process where staff must verify and obtain approval from supervisor(s) where the vacuum truck can be decanted. *(Completed 03/12/25)*.
- Clean the impacted storm sewer before the next rain event. *(Completed 03/12/25)*
- Provide the refresher training to field crews on proper discharge procedures and verification protocols. *(scheduled for the week 03/17/25)*

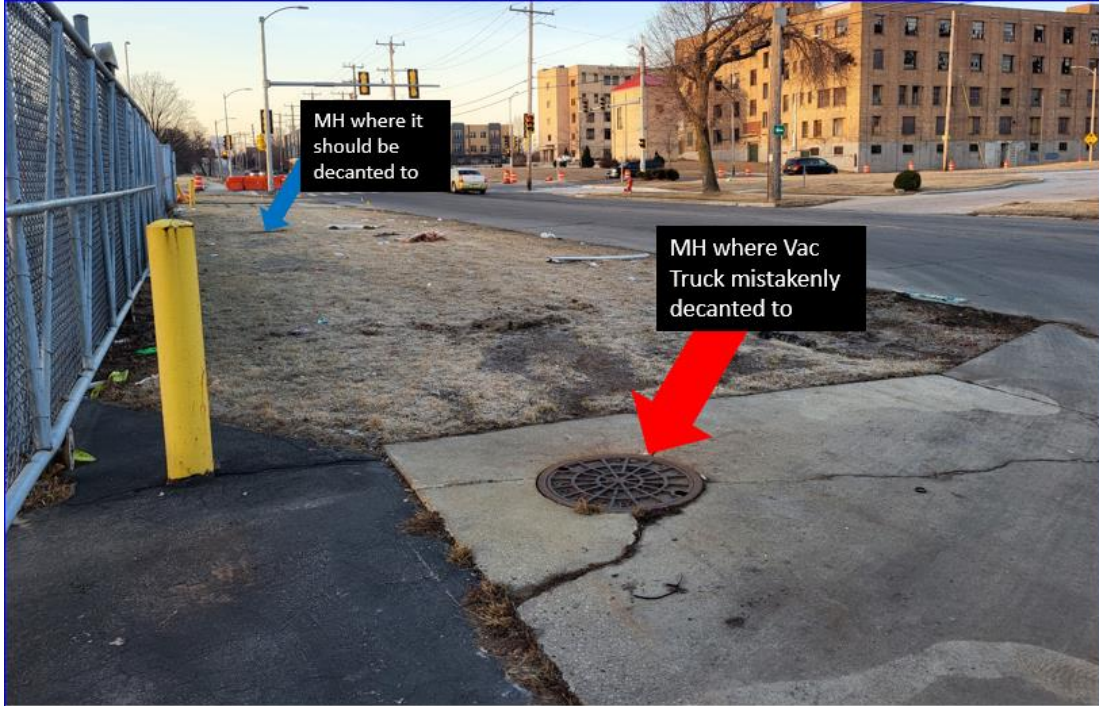
Manhole where Vac Truck decanted into

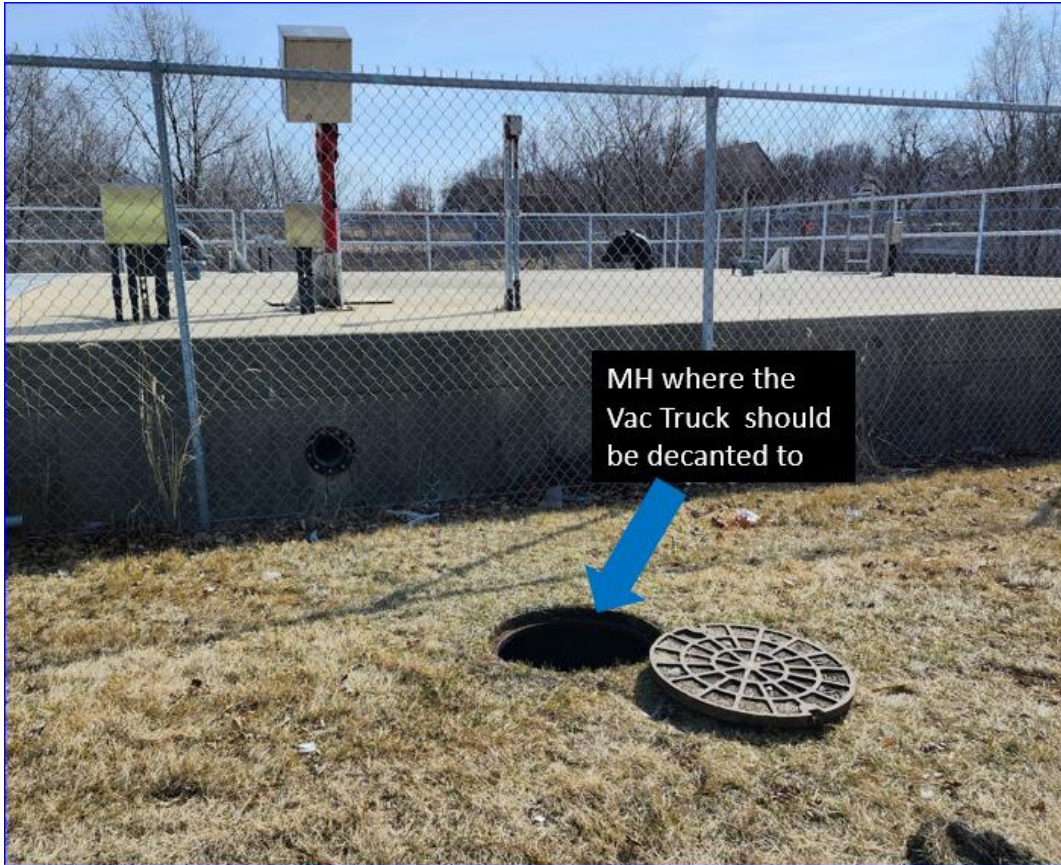
Manhole where Vac Truck SHOULD BE decanted into

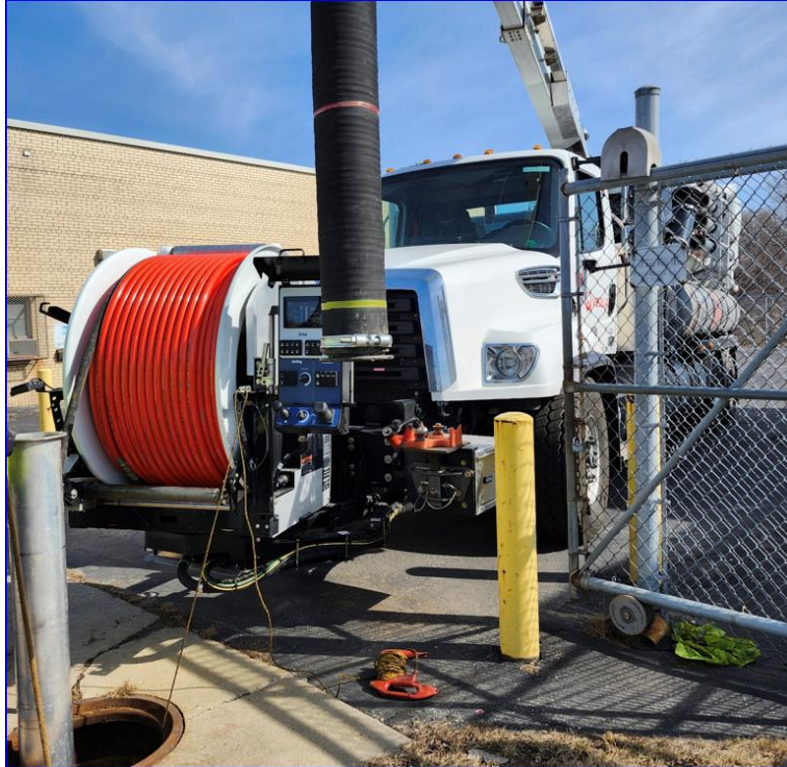
Veolia crew cleaning the impacted sewer on 03/12/25

On March 12, 2025, Veolia crews plugged and cleaned the impacted storm sewer before reopening it for normal operation.

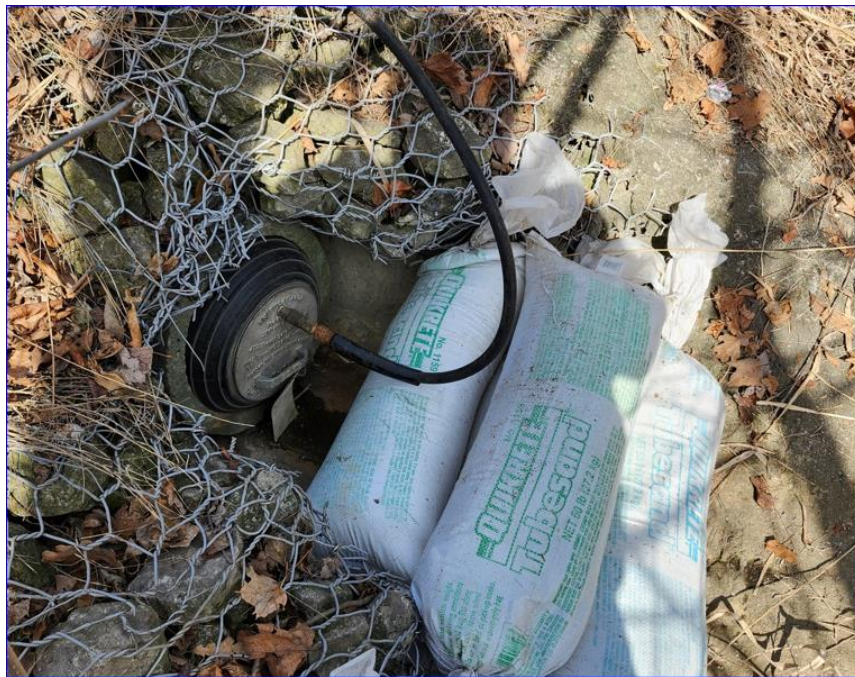
Sewer Plug and Sandbags were used during line cleaning on 03/12/25

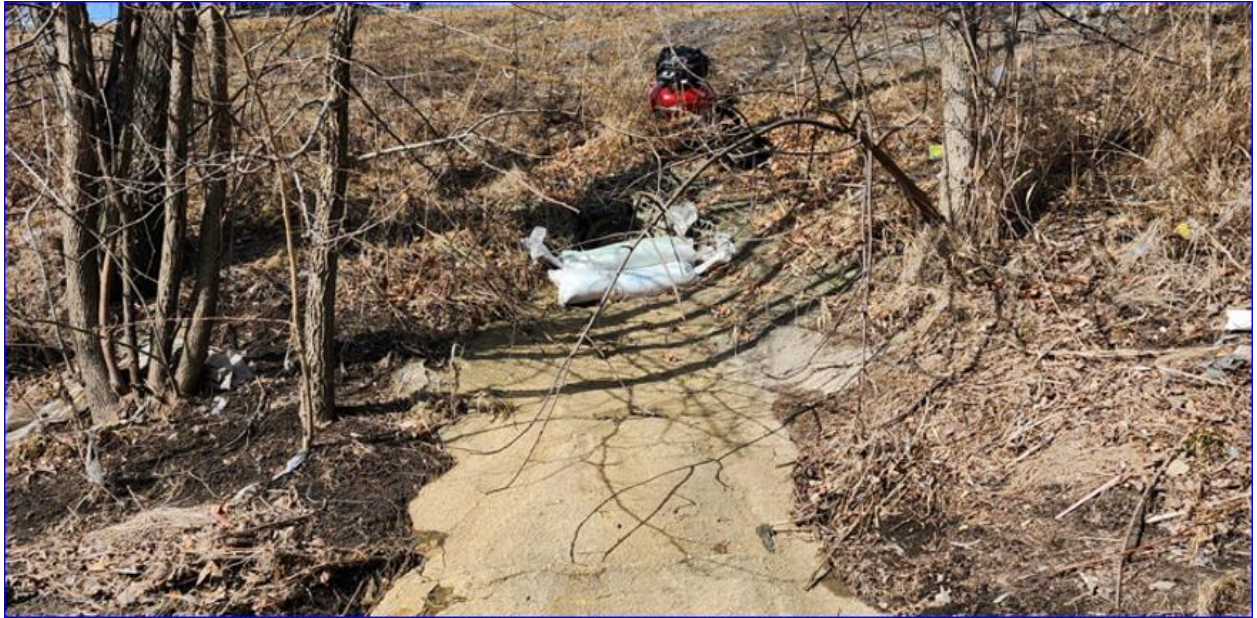
A view of the outfall after the impacted was cleaned on 03/12/25

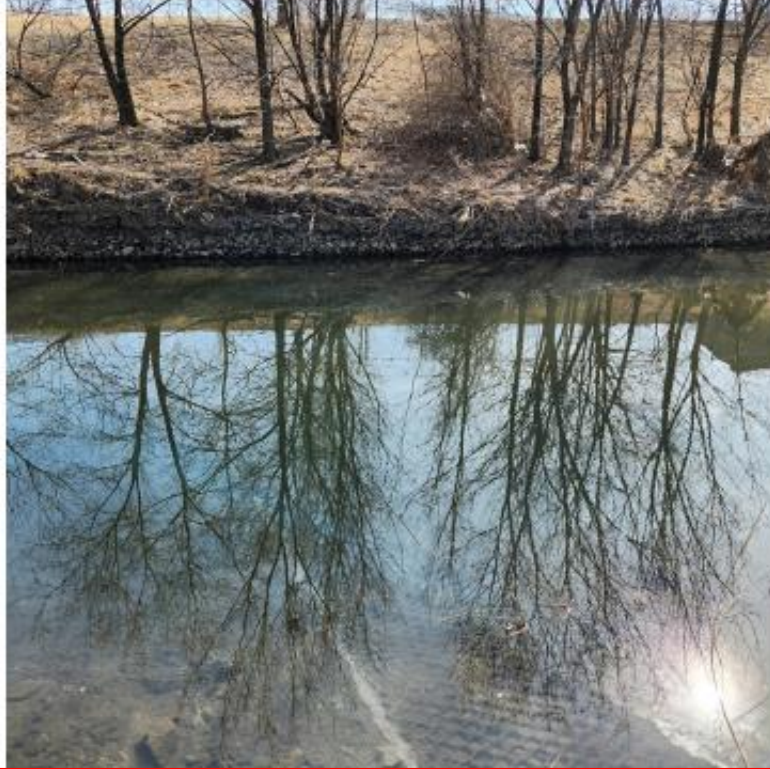
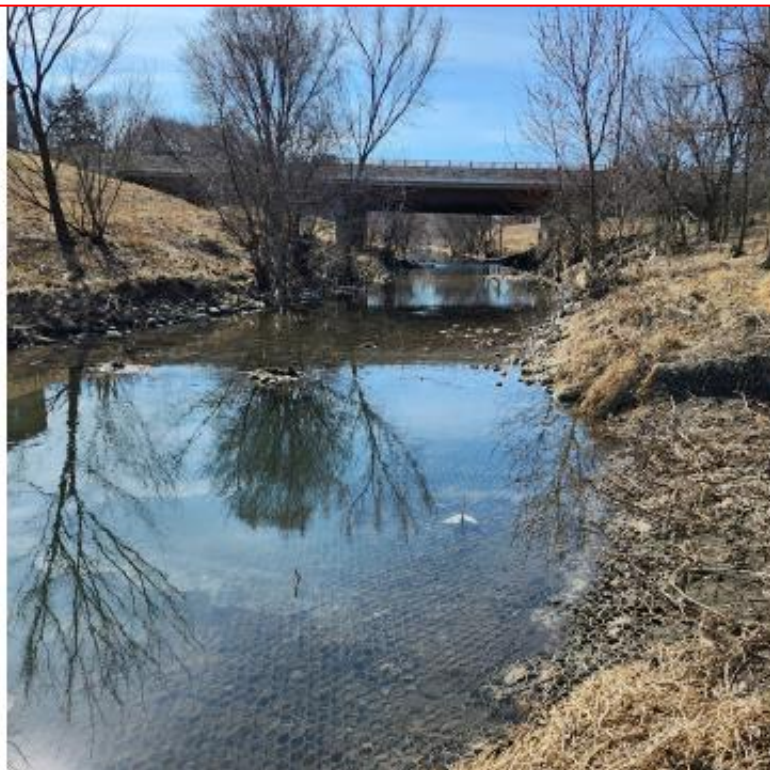
Photos of Lincoln Creek after the incident

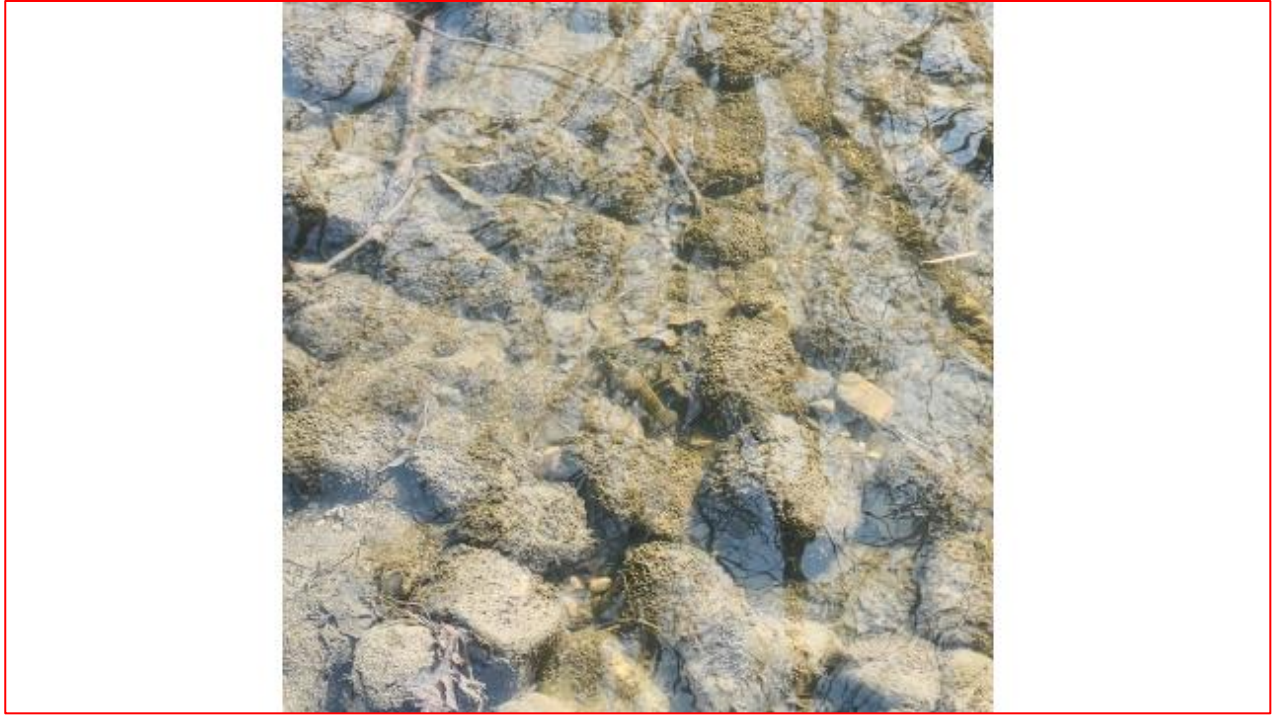
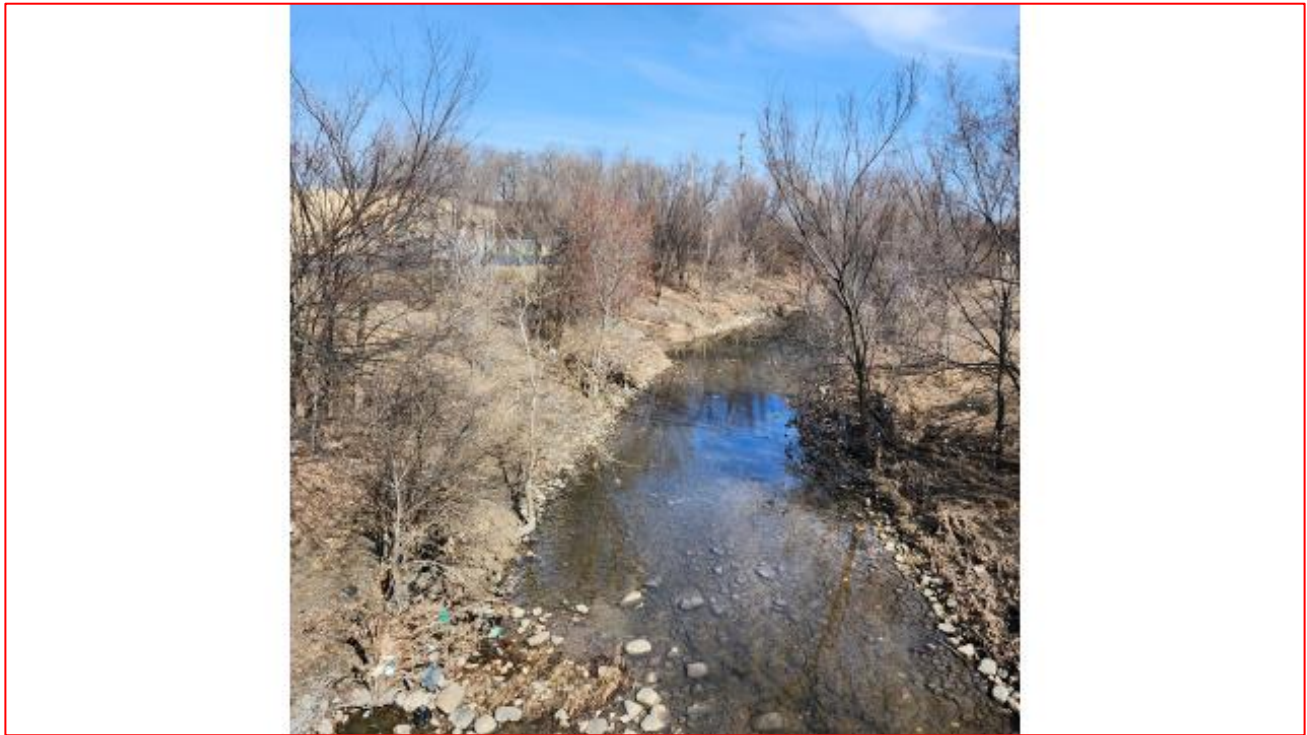
Photos of Lincoln Creek after the incident
